Fatal Fire Investigation

Report of the Hampshire Fire and Rescue Service investigation into the deaths of Firefighters Alan Bannon and James Shears in Flat 72, Shirley Towers, Church Street, Southampton, SO15 5PE, on Tuesday 6 April 2010

**HAMPSHIRE
FIRE AND
RESCUE
SERVICE**

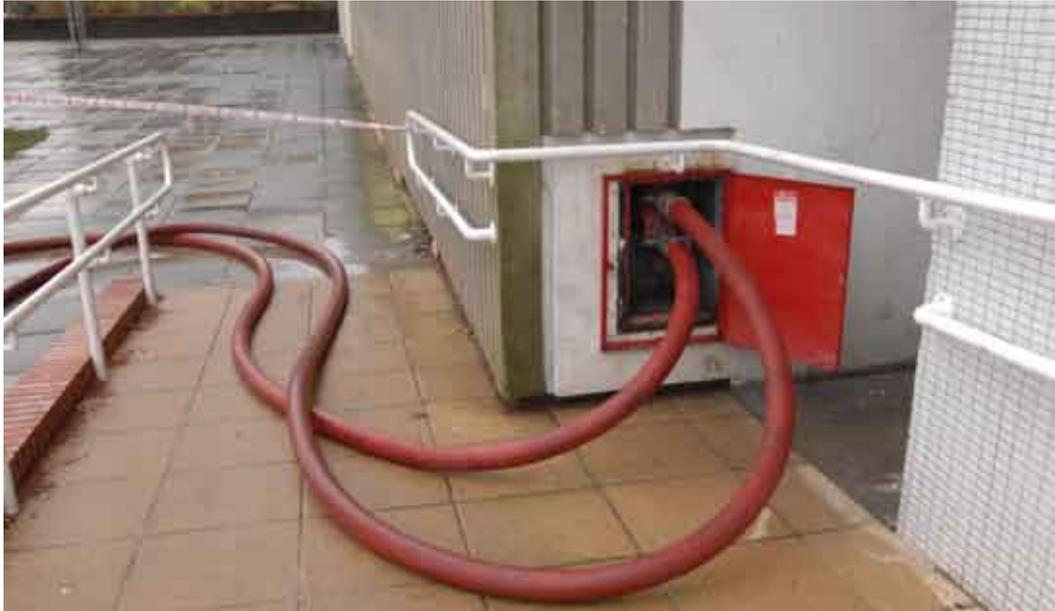
2.2.3 The dry riser in Shirley Towers has outlets on alternate floors, eg, fifth, seventh and ninth floors. Following the incident the dry riser was independently tested and a minor leak noted from the drain valve on the ground floor. This leak had no significant effect on the performance of the dry riser and its ability to provide fire fighting water supplies to the upper floors.

Fig 4: Post incident photograph of dry riser inlet with 2 x 70mm supply hoses connected (Source: Hampshire Constabulary)

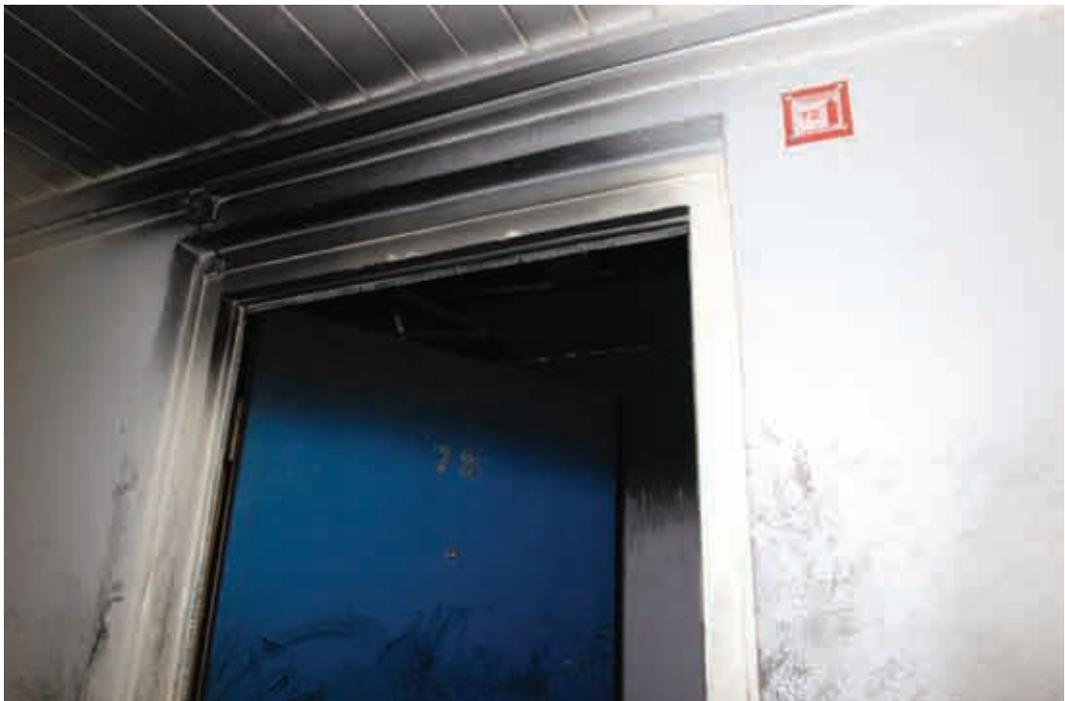
- 2.4.4 Following a previous fire, all flats were individually marked with an arrow to denote whether they were up or down flats (see Figs 10 and 26).

Fig 10: Post incident photograph of flat sign denoting (by arrow) that Flat 72 is an 'up' flat. Note the relatively minor smoke damage (Source: Hampshire Constabulary)

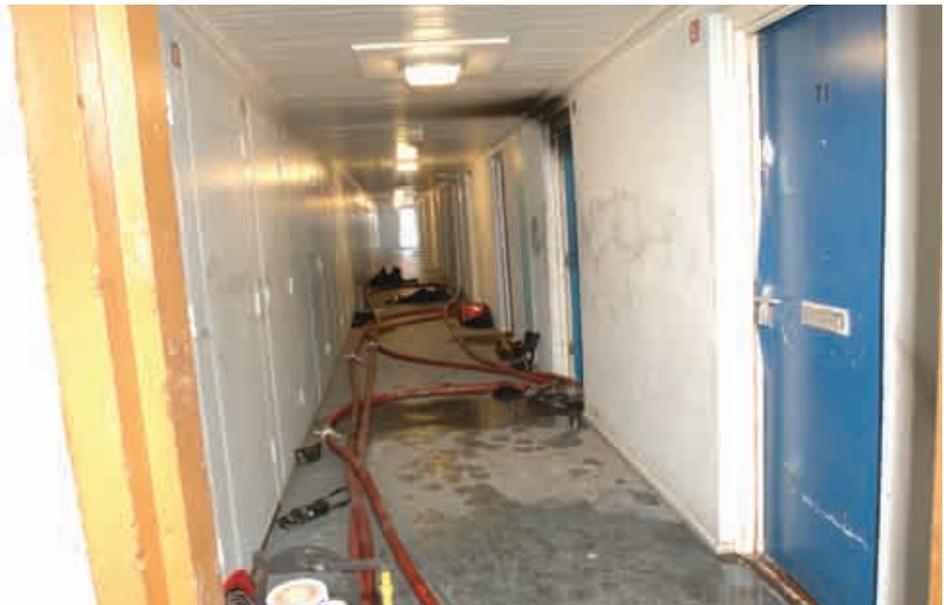
Fig 16: Post incident photograph of ninth floor. The second door on the right is the entrance to Flat 72. The white panel doors on the left are the fire escape doors to other flats. Note the relatively minor smoke damage. (Source: Hampshire Constabulary)

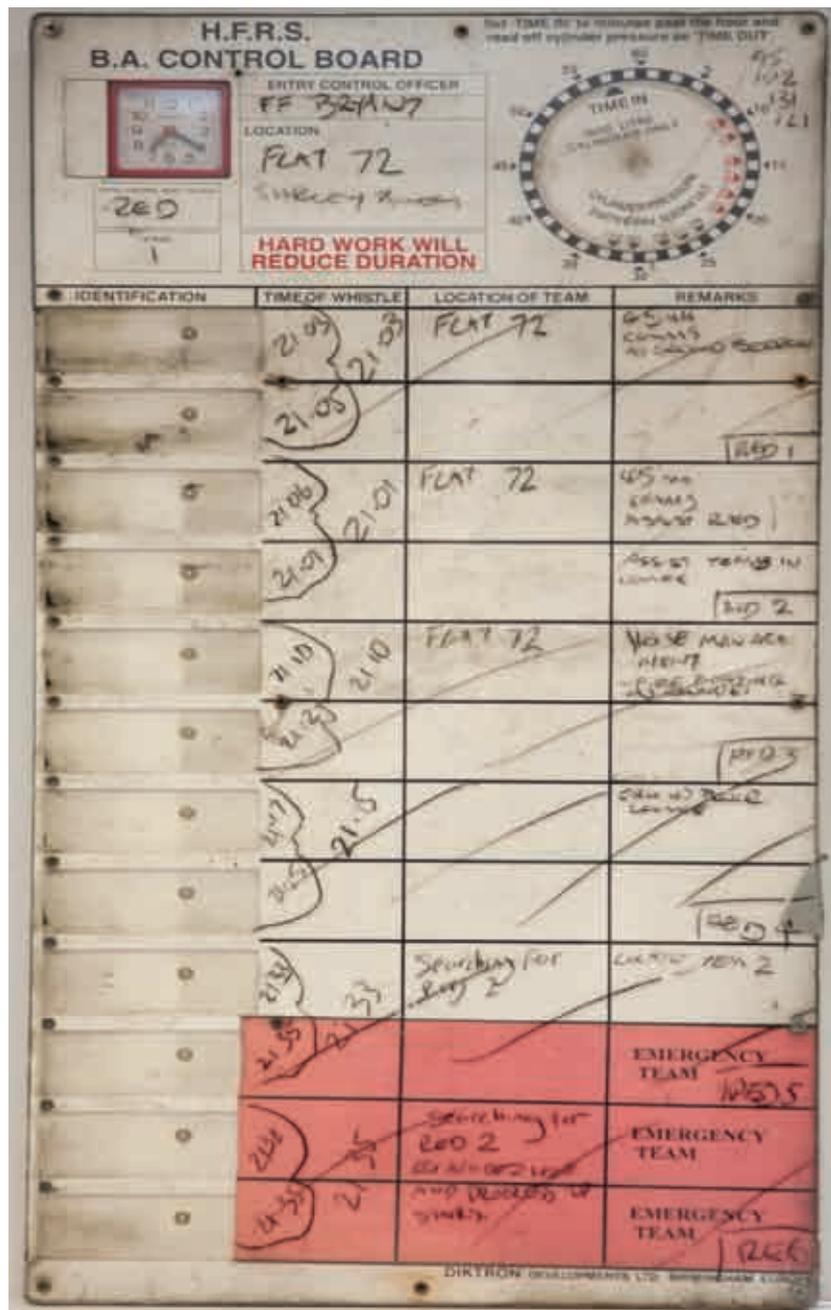
Comment: Photographs taken of the BA board show very little detail regarding the whereabouts/location of the crew recorded. Should an emergency situation arise, such as occurred at this incident, the BAECO would rely on this information to brief emergency crews prior to deployment. Please refer to Finding 4.15 and Recommendation 4.15.1.

Fig 19: Post incident photograph of first BA board in use (Source: Hampshire Constabulary)

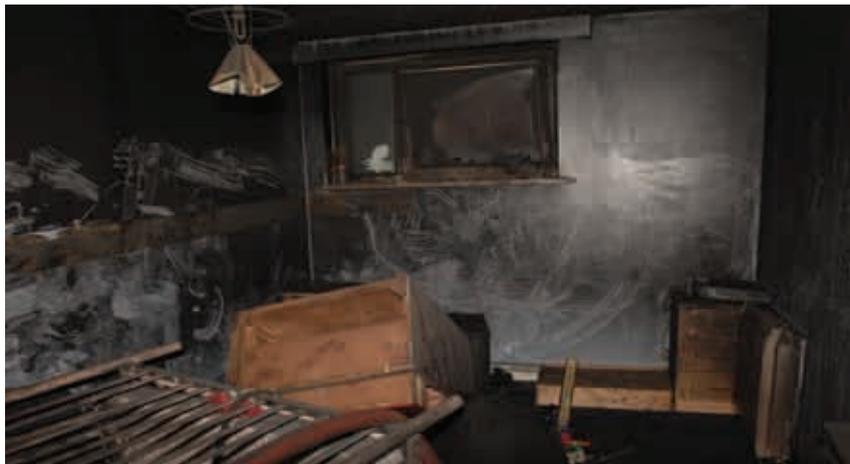
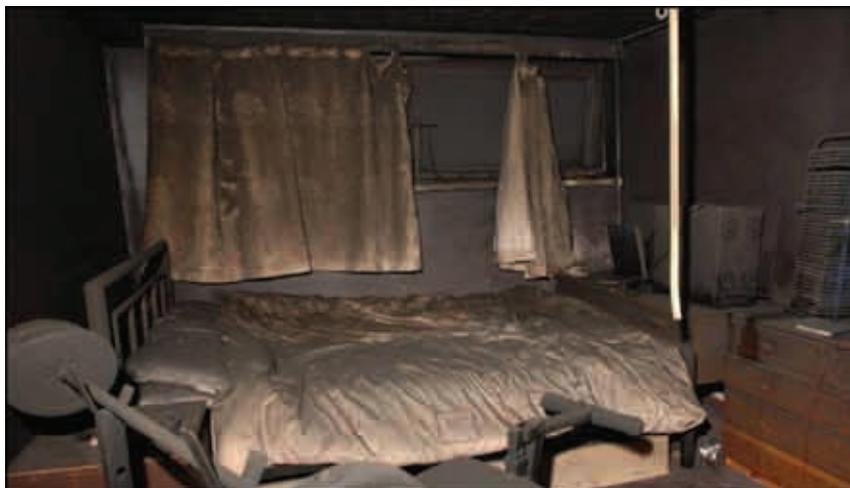
Comment: In his statement Ff Holland said that he believed the main lounge window had ventilated and so his actions of opening the windows in bedrooms 1 and 2 to let the smoke out and clear the room and improve visibility would not have exacerbated the fire situation. He acknowledges that Service procedures required him to seek permission from the IC before carrying out ventilation but chose not to do so on this occasion. At this juncture Red Team 1 were at the highest point of the flat and, having searched the bedrooms, had not located the fire. It is reasonable for them to suppose therefore that the fire must have been below them in the rooms that had not been searched, ie, the lounge and kitchen. Please refer to Finding 2.13 and Recommendations 2.13.1 and 2.13.2.

Fig 20: Post incident photograph of Bedroom 1 showing bedroom window (Source: Hampshire Constabulary)

Fig 21: Post incident photograph of Bedroom 2 showing bedroom window (Source: Hampshire Constabulary)

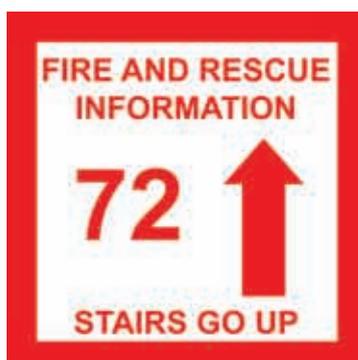
Comment 1: All flats were clearly and individually marked with signage denoting whether they were an up or down flat.

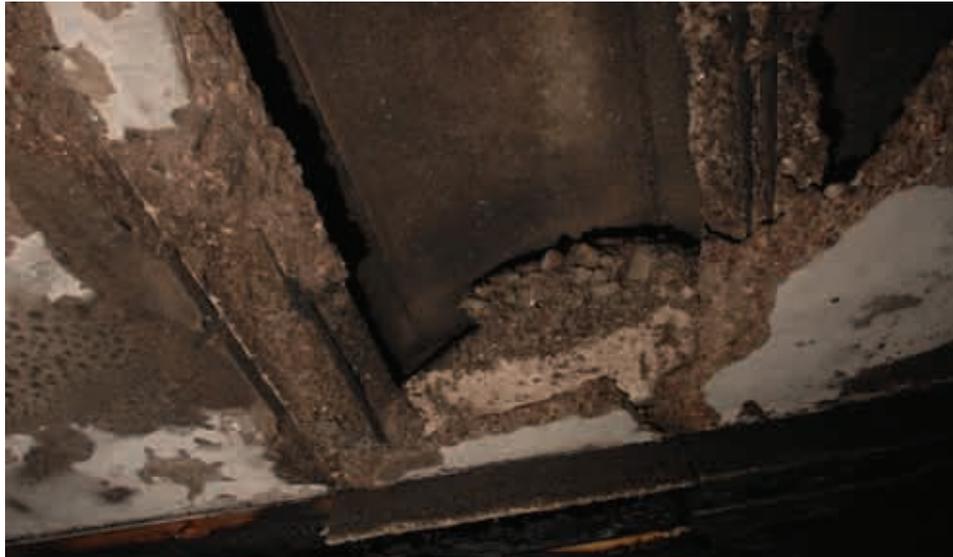
Comment: It is possible that the loud bang was a result of the large piece of concrete ceiling section (Bison Beam), measuring approximately 1.5m x 0.4m x 0.3m noted after the fire to have fallen into the kitchen. Other potential causes of the noise include the television exploding or an aerosol rupturing. Please refer to Finding 2.9 and Recommendation 2.9.1.

Fig 27: Post incident photograph of kitchen ceiling showing the fire damage to the concrete beams (Source: Hampshire Constabulary)

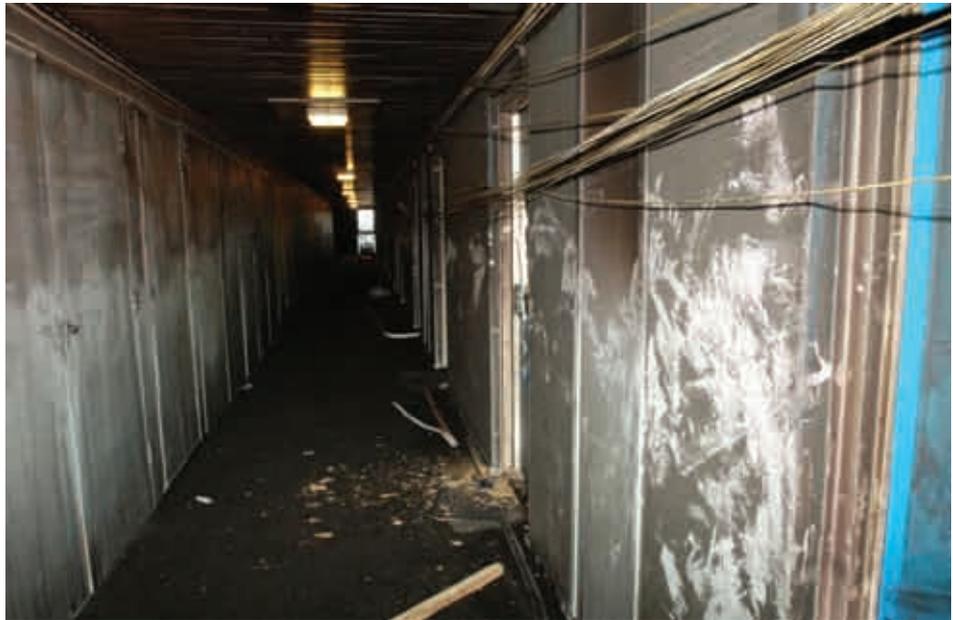
Fig 30: Post incident photograph showing conditions on the eleventh floor after the escape door from Flat 72 was left open. Note the displaced cables. (Source: Hampshire Constabulary)

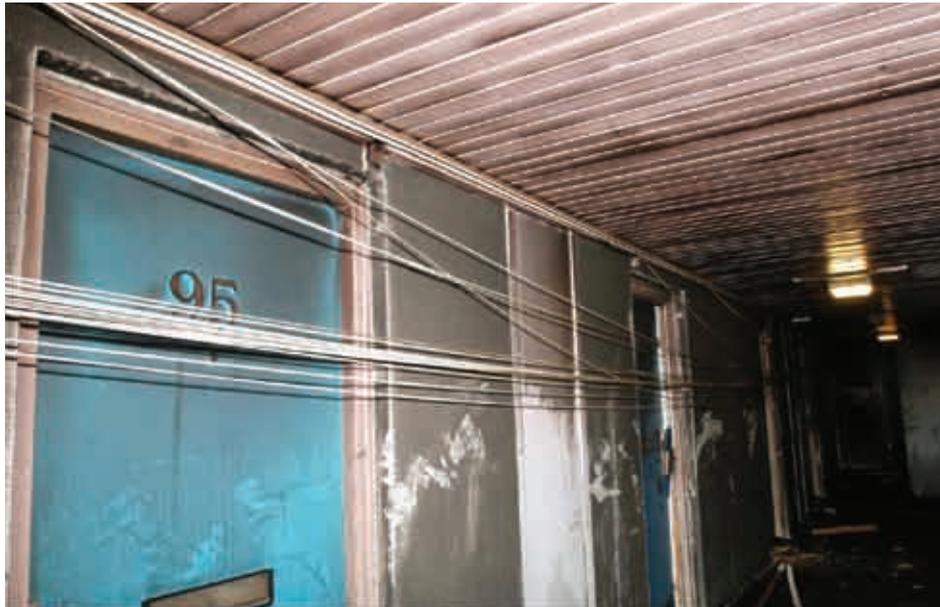
Fig 31: Post incident photograph of the eleventh floor landing showing displaced cables (Source: Hampshire Constabulary)

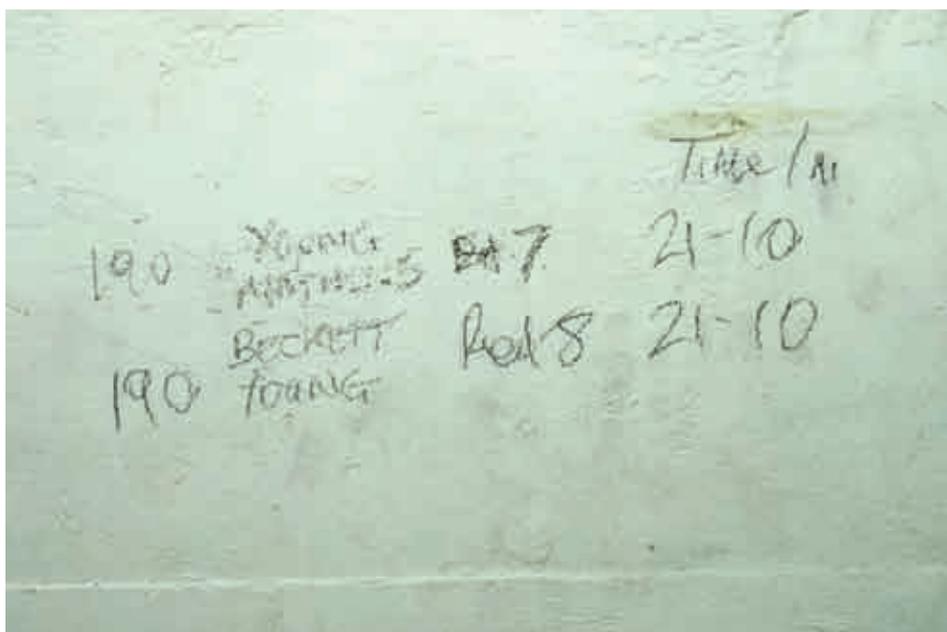
Comment 3: The BAECO showed initiative in the circumstances by recording the additional BA crews on the adjacent wall. However, the entries on the wall were incorrect with CM Young's name appearing twice and Ff Benfield's name being missed. There is also doubt over the accuracy of recorded time of entry.

Fig 33: Post incident photograph of wall adjacent to the BA ECP showing entries marked on the wall. Note the absence of Ff Benfield from Red Team 8 and the duplication of CM Young. (Source: Hampshire Constabulary)
