Fatal Fire Investigation

Report of the Hampshire Fire and Rescue Service investigation into the deaths of Firefighters Alan Bannon and James Shears in Flat 72, Shirley Towers, Church Street, Southampton, SO15 5PE, on Tuesday 6 April 2010

**HAMPSHIRE
FIRE AND
RESCUE
SERVICE**

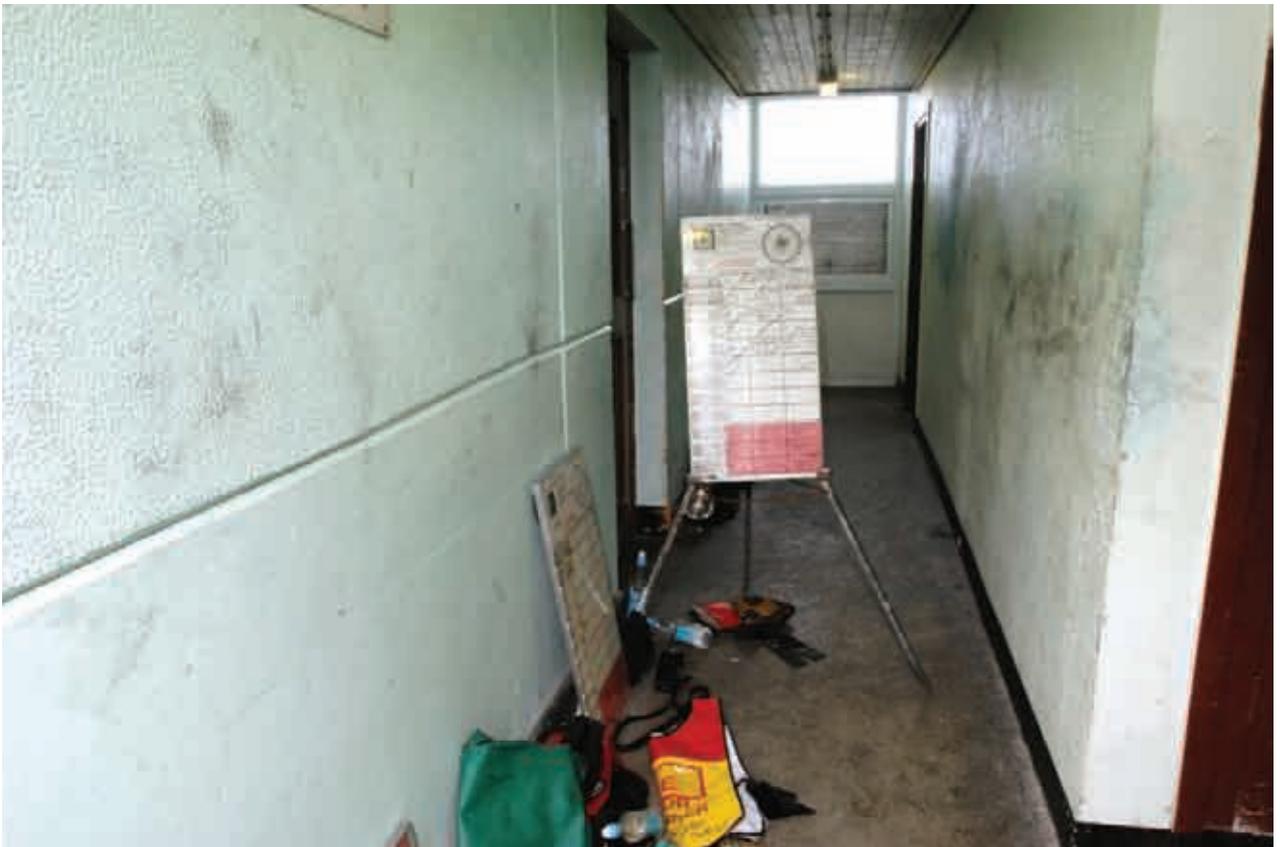
Estimated Time Ff Bryant (BAECO) sets up BA board in the seventh floor outer lift lobby and takes a radio from CM Launchbury.

Fig 12: Post incident photograph showing location of first BA control board on the seventh floor (Source: Hampshire Constabulary)

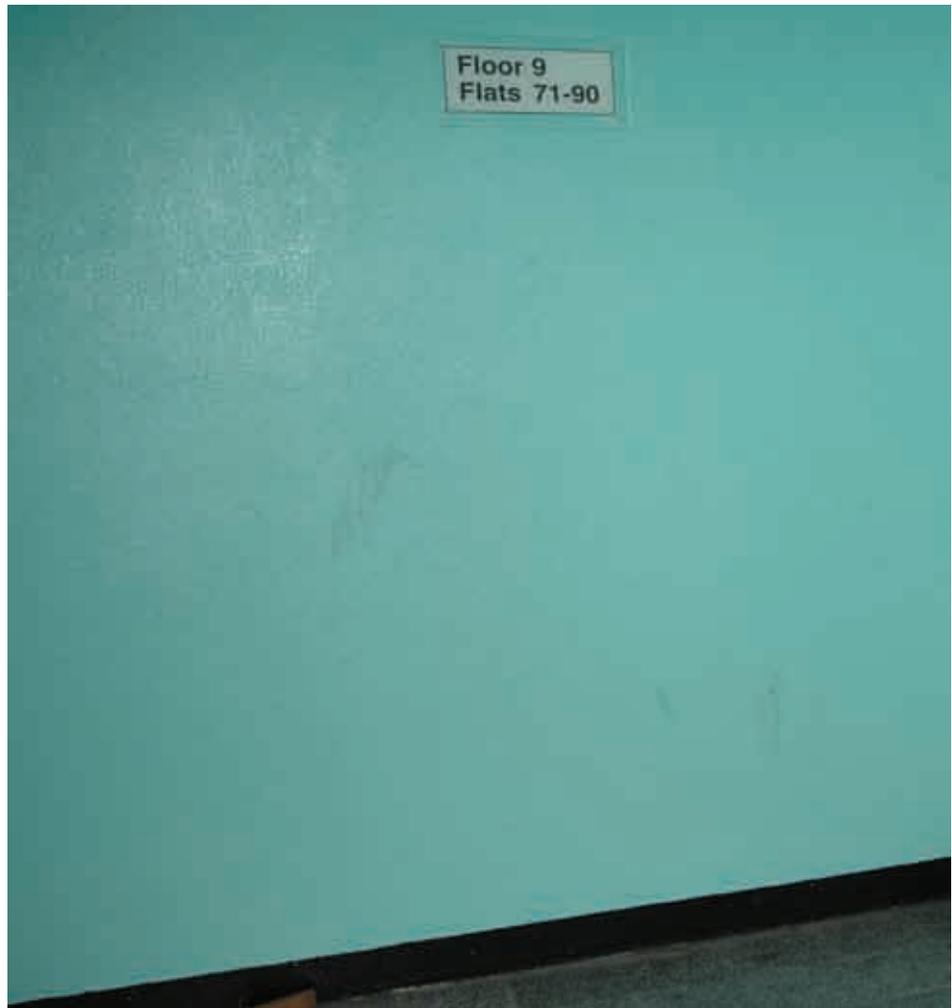
Fig 14: Post incident photograph of ninth floor showing sign displaying floor and flat detail (Source: Hampshire Constabulary)

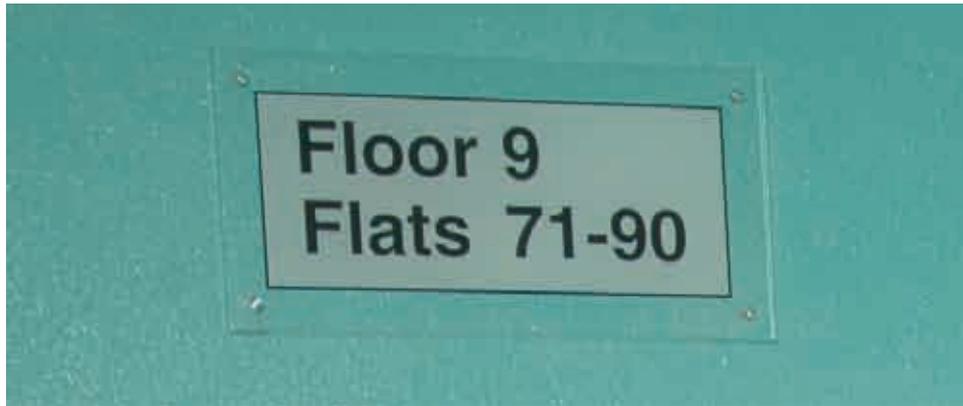
Fig 15: Post incident photograph showing close up of sign on ninth floor
(Source: Hampshire Constabulary)

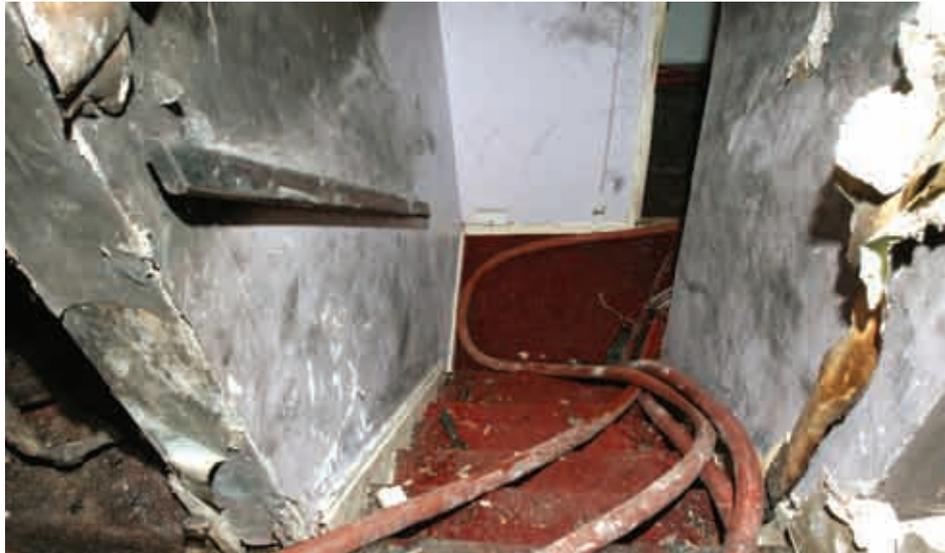
Fig 18: Post incident photograph from lounge level down stairs to entrance lobby. (Source: Hampshire Constabulary)

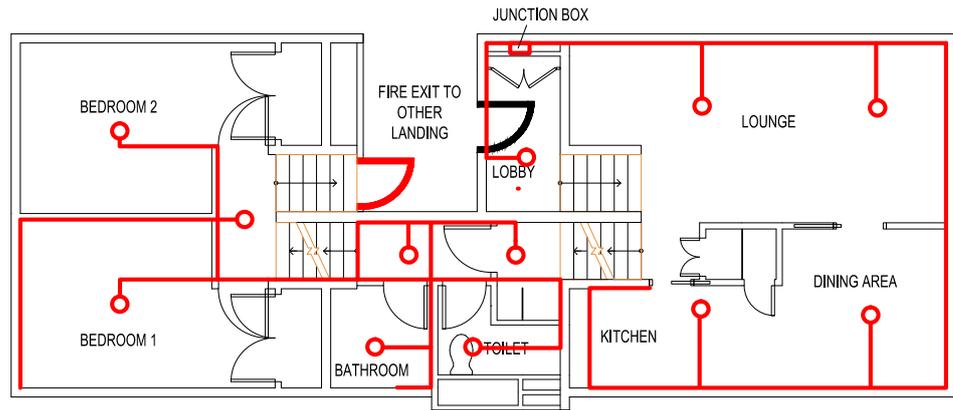
2.2.4 Shirley Towers was electrically rewired between 1995 and 1996. The replacement wiring was routed along the walls of the common areas and within the individual flats via external plastic trunking. This was compliant with the electrical installation regulations in force at the time of installation.

Comment 1: These were the first firefighters to become entangled in fallen cables. These cables had been released from surface mounted plastic cable trunking which had softened and melted as a result of the fire. Please refer to Finding 2.8 and Recommendations 2.8.1, 2.8.2, 2.8.3 and 2.8.4.

Fig 22: Plan view of Flat 72 showing wiring diagram.

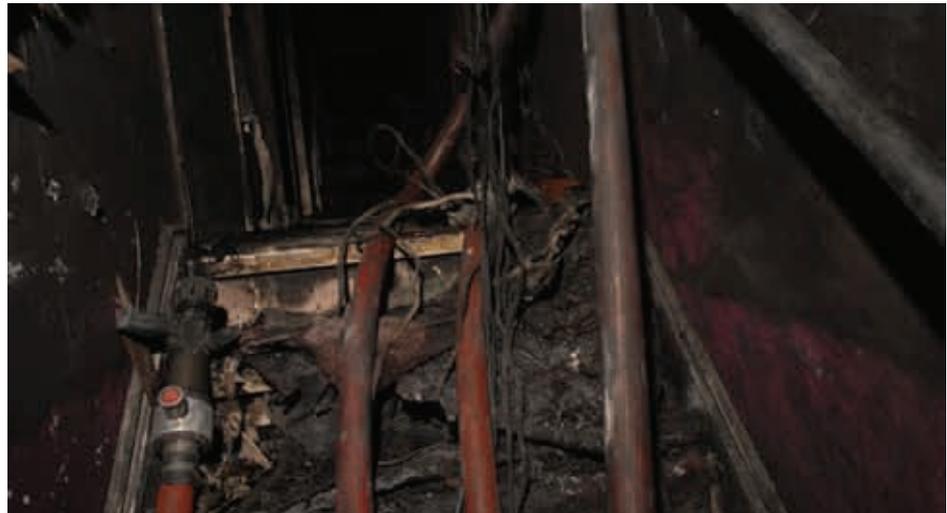
Fig 23: Post incident photograph looking up stairs from lounge window towards bathroom level. (Source: Hampshire Constabulary)

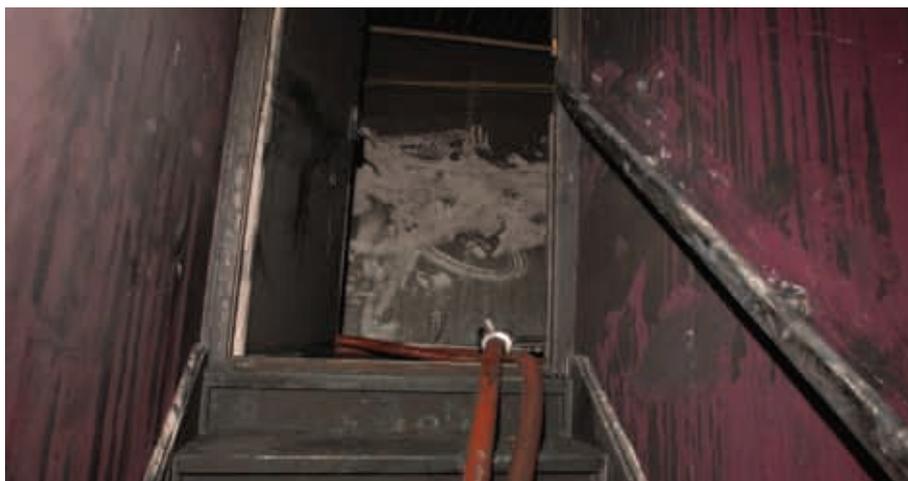
Estimated Time Ff Holland leaves Flat 72 via the fire escape door to the eleventh floor. Upon exiting he realises that Ff Ryan is not with him. Turning around towards the escape door, he sees Ff Ryan's helmet through the escaping smoke, he is entangled in cables preventing his final exit from the staircase. At this point Ff Ryan states that he thought he was not going to get out and that he was going to die. Ff Holland assisted Ff Ryan to remove the cables and they both moved into the eleventh floor corridor.

Fig 25: Post incident photograph up fire escape stairs from bedroom level towards eleventh floor fire escape door (open). (Source: Hampshire Constabulary)

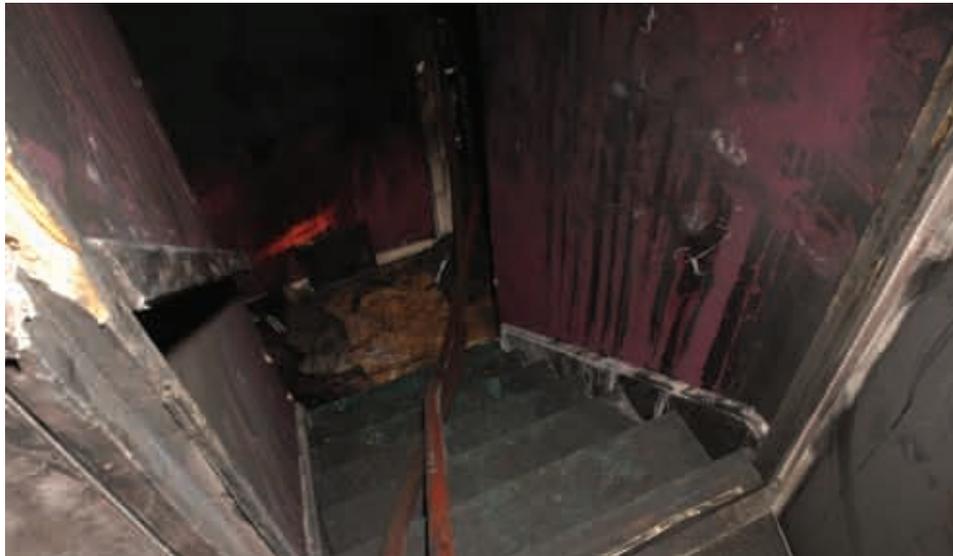
Fig 28: Post incident photograph from eleventh floor fire escape door down staircase to bedroom floor level (Source: Hampshire Constabulary)

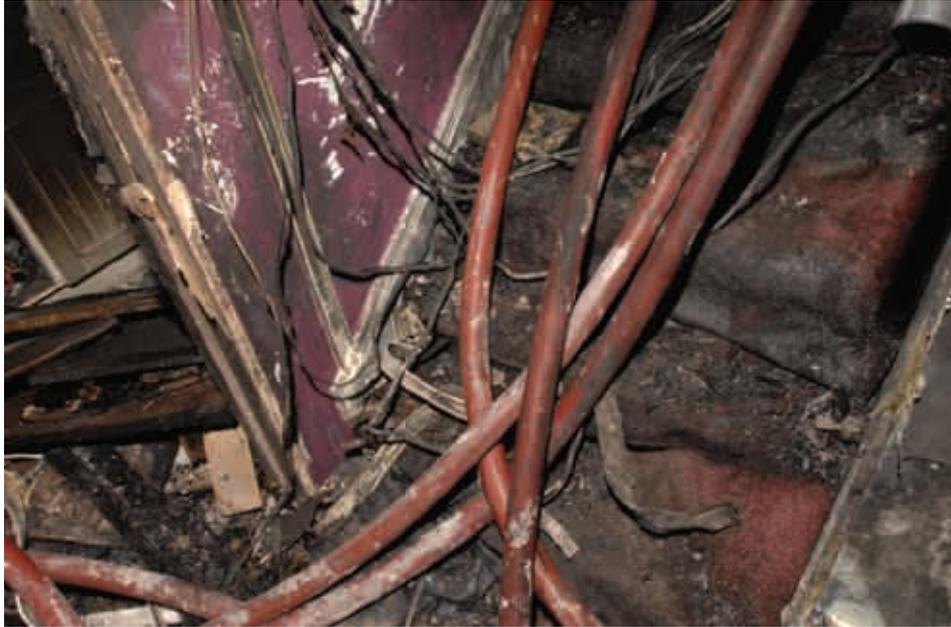
Fig 32: Post Incident photograph from lounge up stairs towards bathroom level. Note entrance to kitchen on left. (Source: Hampshire Constabulary)

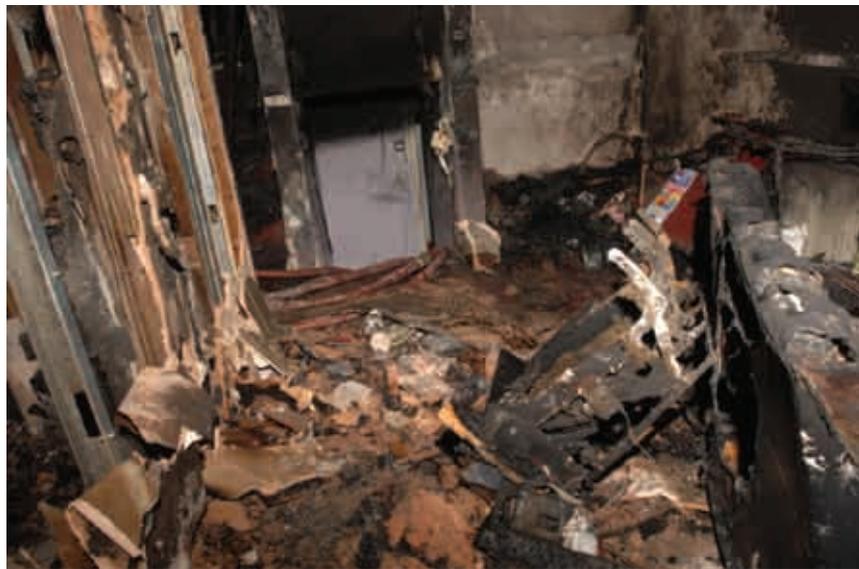
Fig 35: Post incident photograph of lounge from the window back towards staircase from entrance (middle) and the stairs leading up to the bedrooms (left hand side). (Source: Hampshire Constabulary)

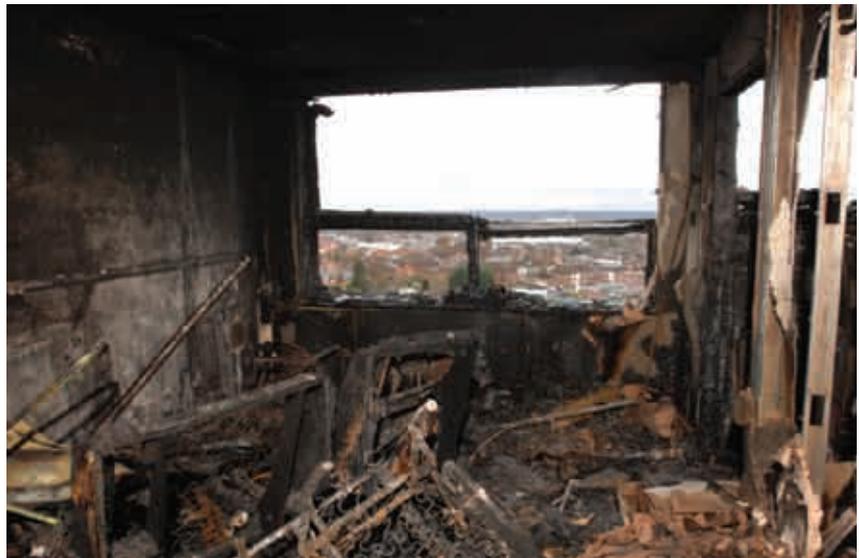
Fig 36: Post incident photograph from top of entrance stairs towards lounge window. (Source: Hampshire Constabulary)

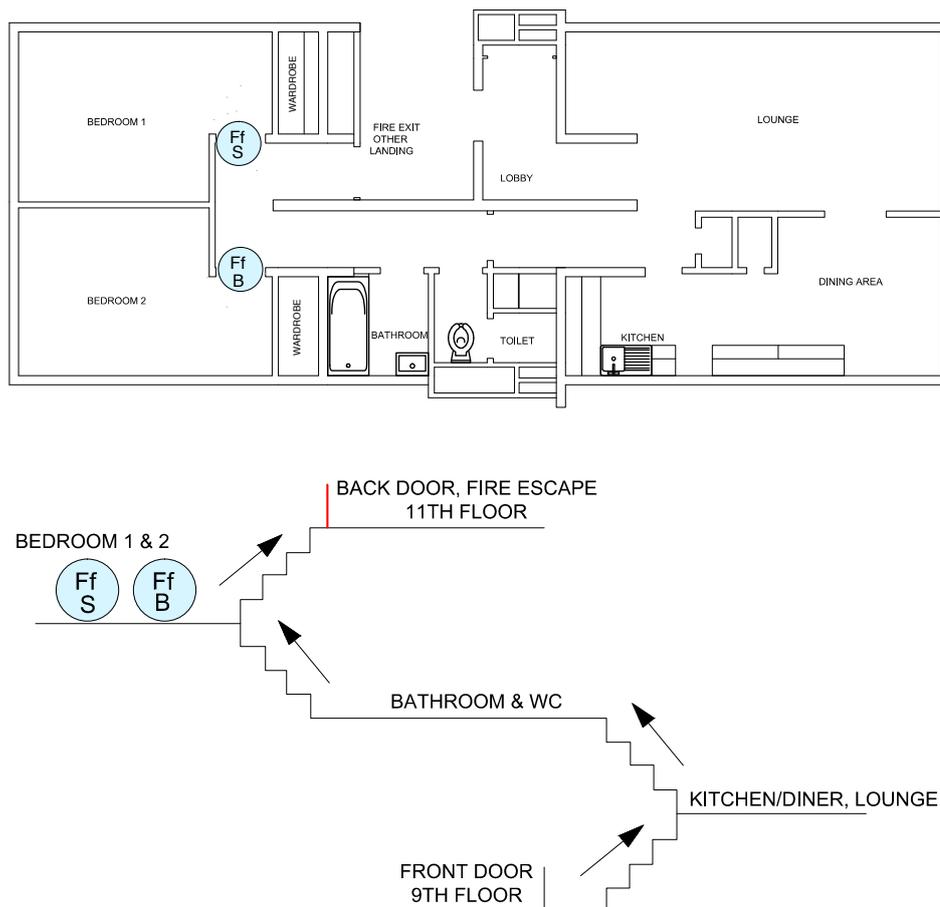
- 21:37
Estimated Time Red Team 10 (T/CM Martin and Ff Bray) pass the first casualty (Ff Bannon) to Red Team 11 (A/CM Timms and Ff Hickman) and CM James and return to assist Red Team 9 (Ffs Hair and Keyworth) who have located the second casualty (Ff Shears).

Fig 38: Location (plan and elevation) of Red Team 2 (Ffs Bannon and Shears).
